WARNER GAP HOLLOW DAM

(EDGEMONT RESERVOIR)

NDI NO. MD 00006

PHASE I INSPECTION REPORT NATIONAL DAM INSPECTION PROGRAM

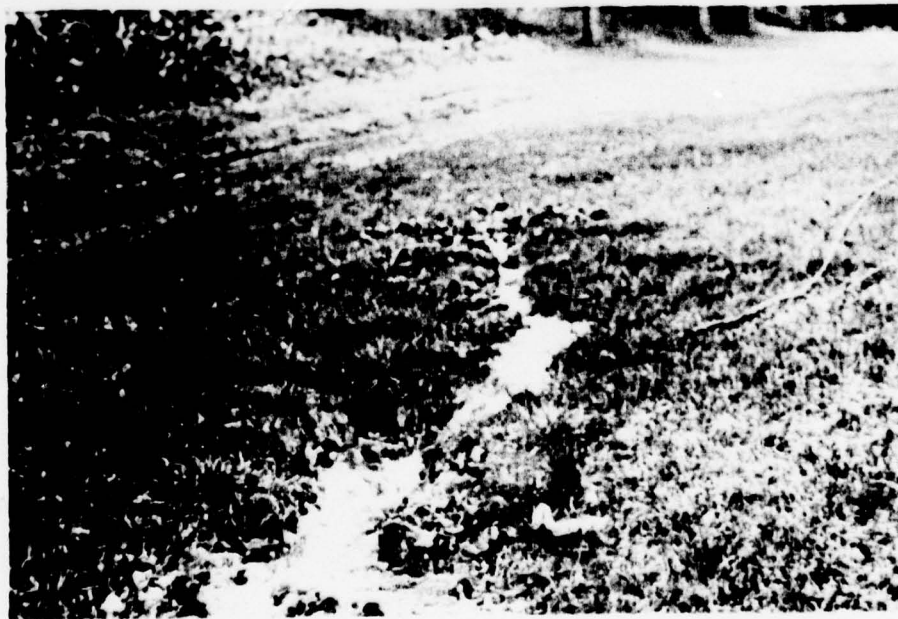
3. The 1968 investigation judged the seepage activity beyond the left abutment not as serious as the leakage at the right abutment and further evaluation was deferred until the spring of 1969. No record of the deferred evaluation was found during the data review. Based upon the relative clarity and apparent seasonal fluctuation of seepage, the source of discharge at the left abutment appears to be primarily spring activity not directly affecting the stability of the dam. However, the quantity and turbidity of seepage should be monitored on a routine basis.

Flow from left side conveyed via system of tile and plastic pipe.
precise location of sources, if any, within dam foundation unknown:
flow clear and approximated at 15 gpm.

SEEPAGE, LEFT SIDE BEYOND TOE

1. Initiate an engineering study to evaluate spillway capacity and determine remedial measures to reduce the overtopping potential at the dam.
2. The 30-inch drain valve should be restored to an operable condition and should be provided with a positive seal on the upstream side of the dam.
3. The seepage at the left abutment should be monitored on a routine basis to detect any changed conditions in quantity or turbidity. Flow measurements should be made with the use of a weir.

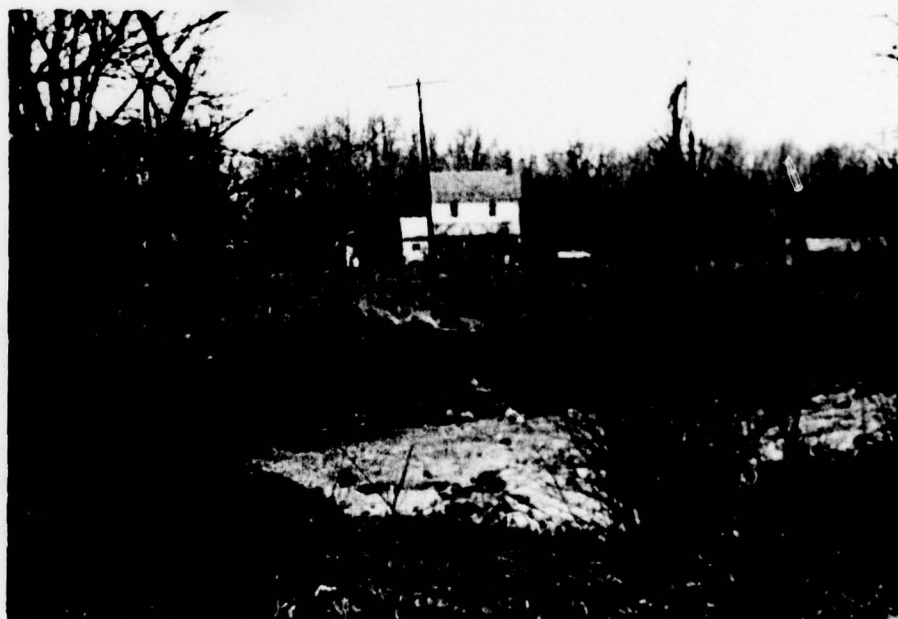
DOWNSTREAM DWELLING
(STATION #4 OF
HYDRAULIC ROUTINGS)
